**UNITED STATES ENVIRONMENTAL PROTECTION AGENCY**

Re: Notice of Violation  
RCRA Compliance Evaluation Inspection – Mid-City Plating Company  
EPA I.D. No.: IND 006 049 456

# Photographs for Mid City Plating Company CEI 6/22/2010

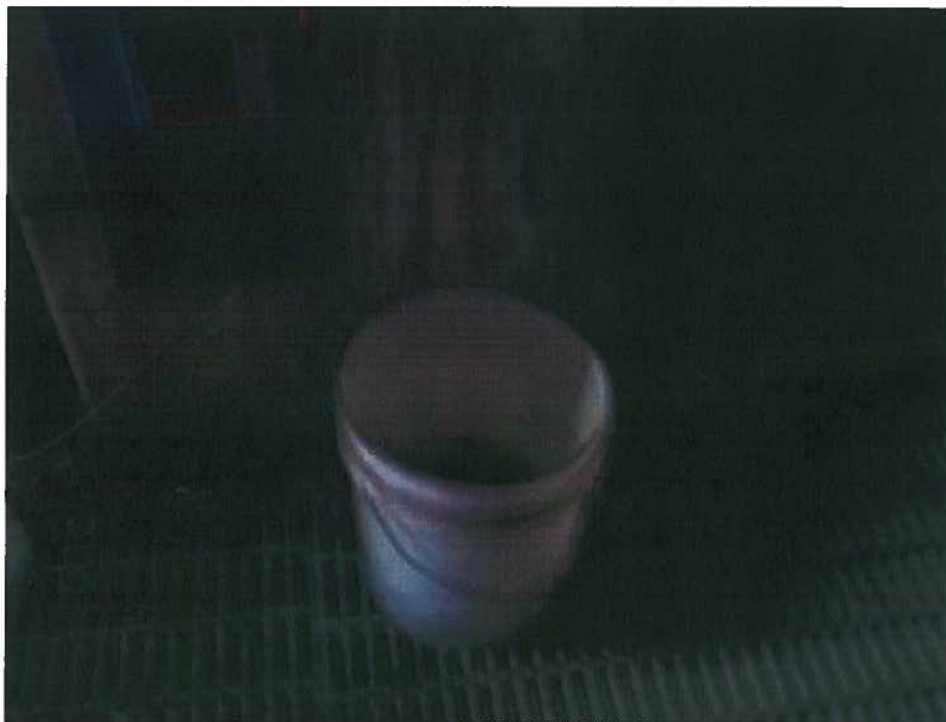
Open bucket of material located on trench near the E-coat line. E-coat line was in operation 1 or 2 shifts per month.

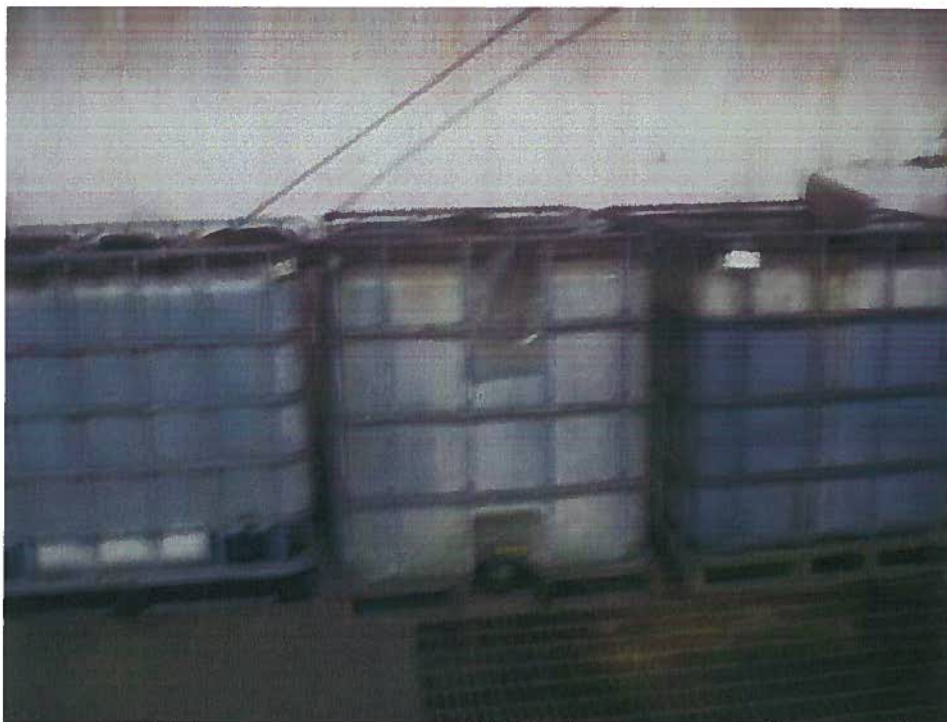
Totes that contained various plating line waste water prior to be treated in the WWT unit were being stored near the collection pit. The totes were not labeled or dated.

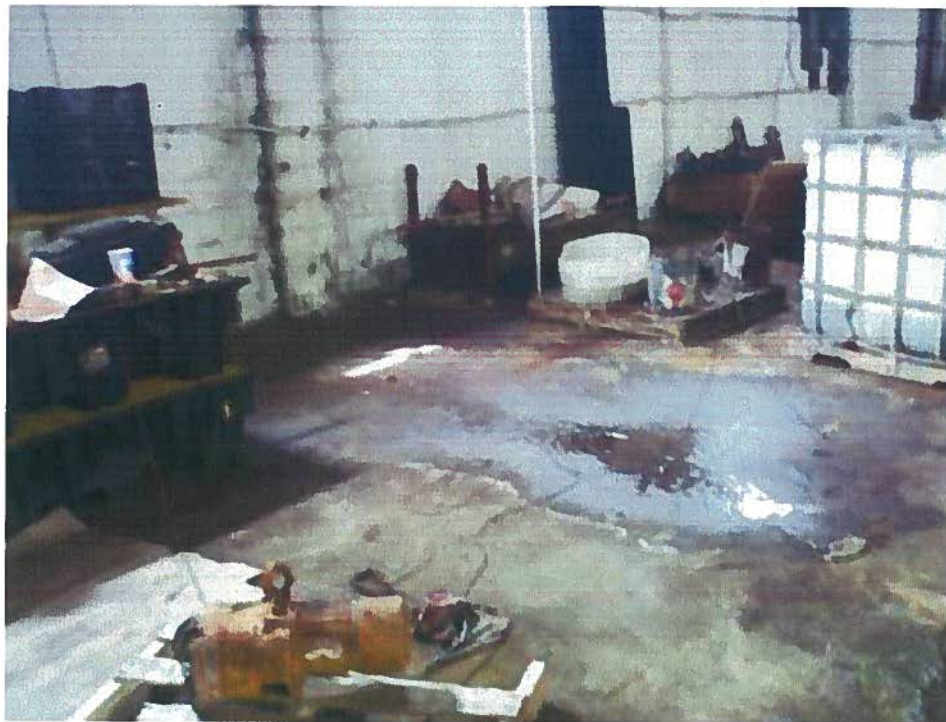
Barrel Row Line had been removed. Liquid was located on the floor. Equipment was being stored within the area.

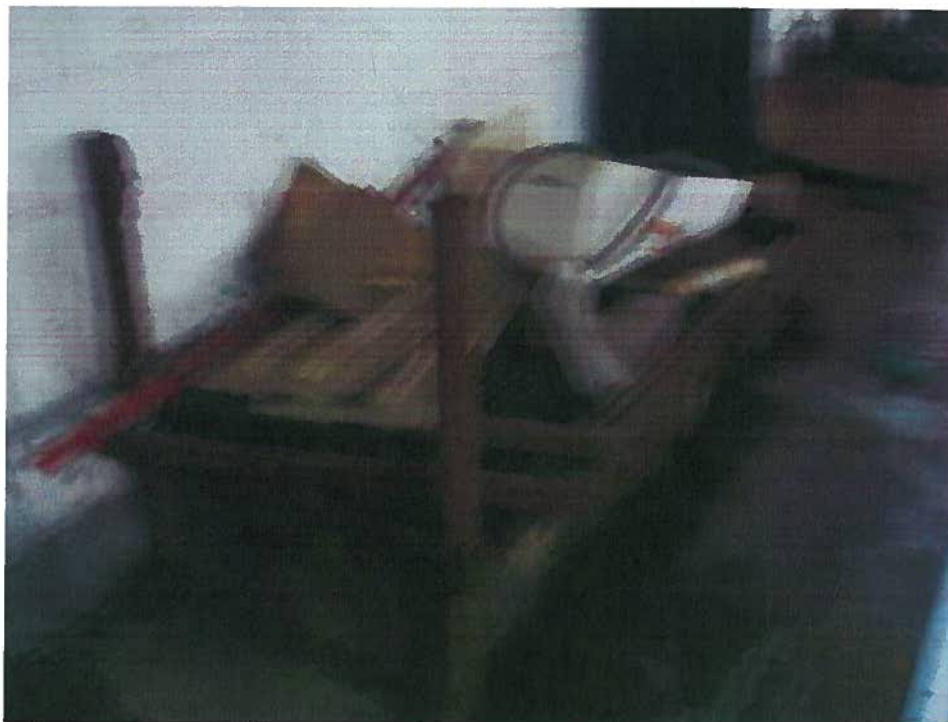
Barrel Row Line had been removed. Liquid and other material were located on the floor. Equipment was being stored within the area. Rectangular equipment was being used as an oil bin.

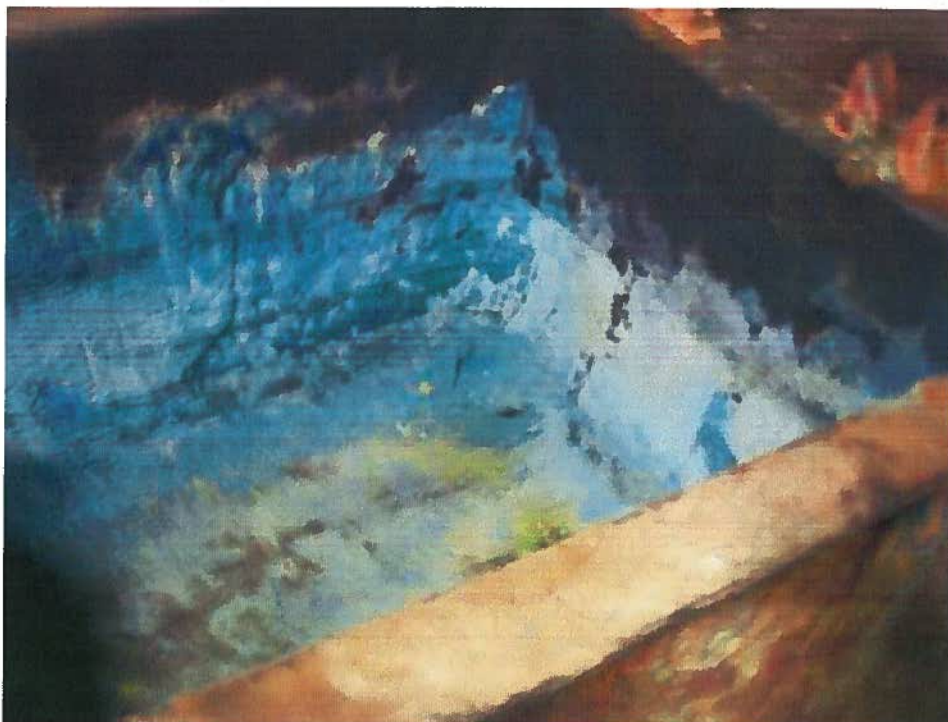
Barrel Row line bath. No liquid was located inside; however dried blue/white material was still located inside of bath. (Barrel Row line had been discontinued and tank was going to be dismantled.)

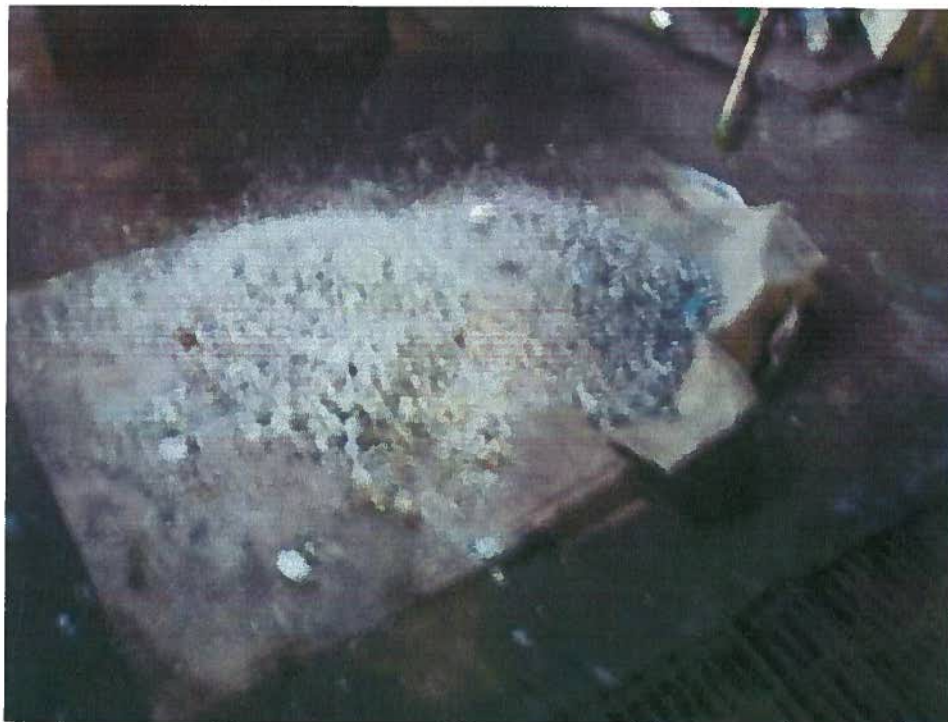
A broken fluorescent light bulb was also located on the floor of this area. Zinc metal, obtained from the plating line, was being stored on a piece of fabric on the floor in this area, as well, near the broken fluorescent light bulb. *See, photographs 43 and 44.*

Zinc metal was being stored on a piece of fabric, located on the floor, near the Barrel Row line.

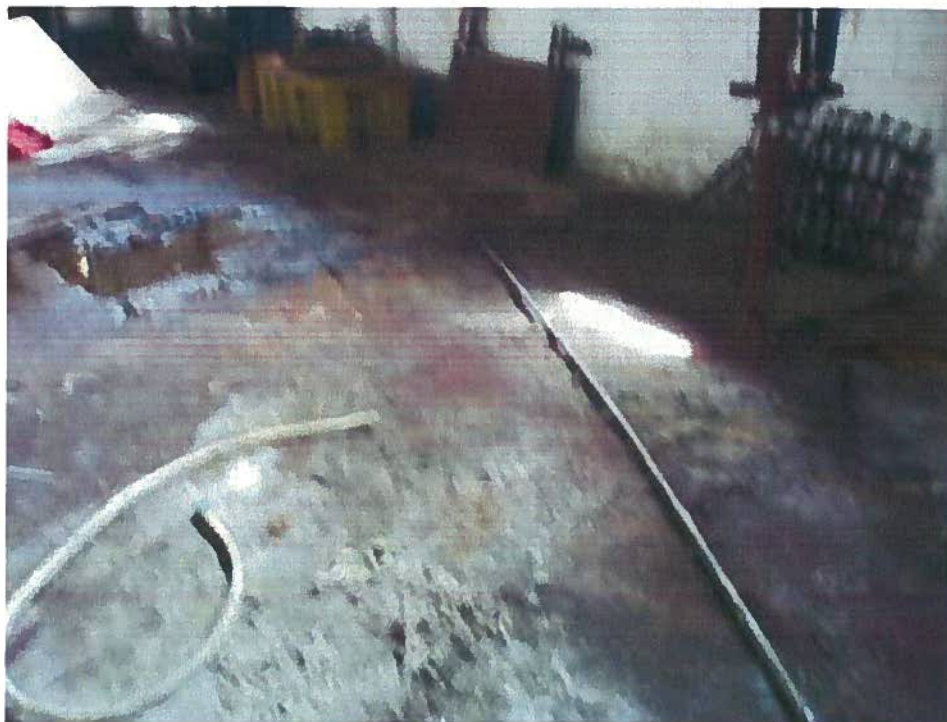
Barrel Row line location. Liquids were being stored on the floor. Equipment was being stored within the area.

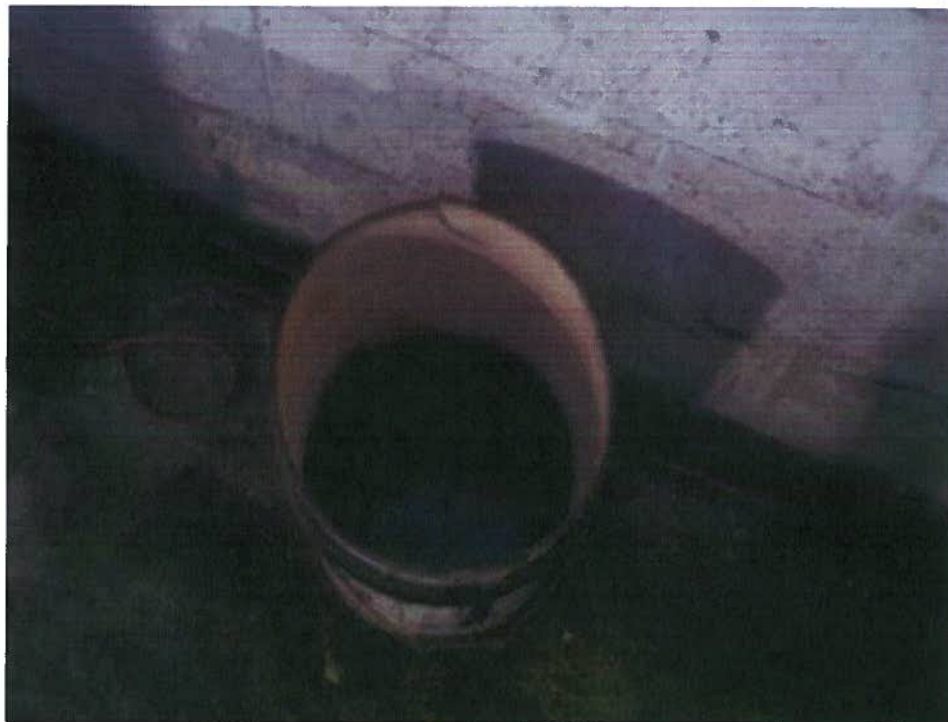
An oily liquid was being stored in an open 5-gallon bucket. The oil was described as hydraulic oil.

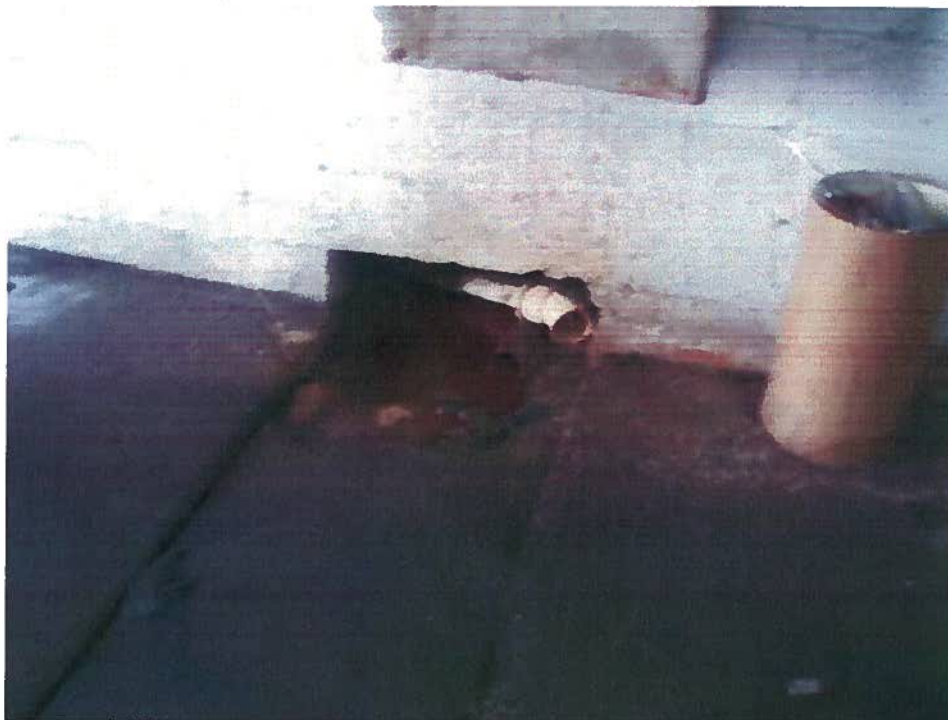
Trench located on the floor in between rooms. Red un-identified red liquid was being stored within the trench. Pipes were located inside of the trench and were not connected from the exposed ends.

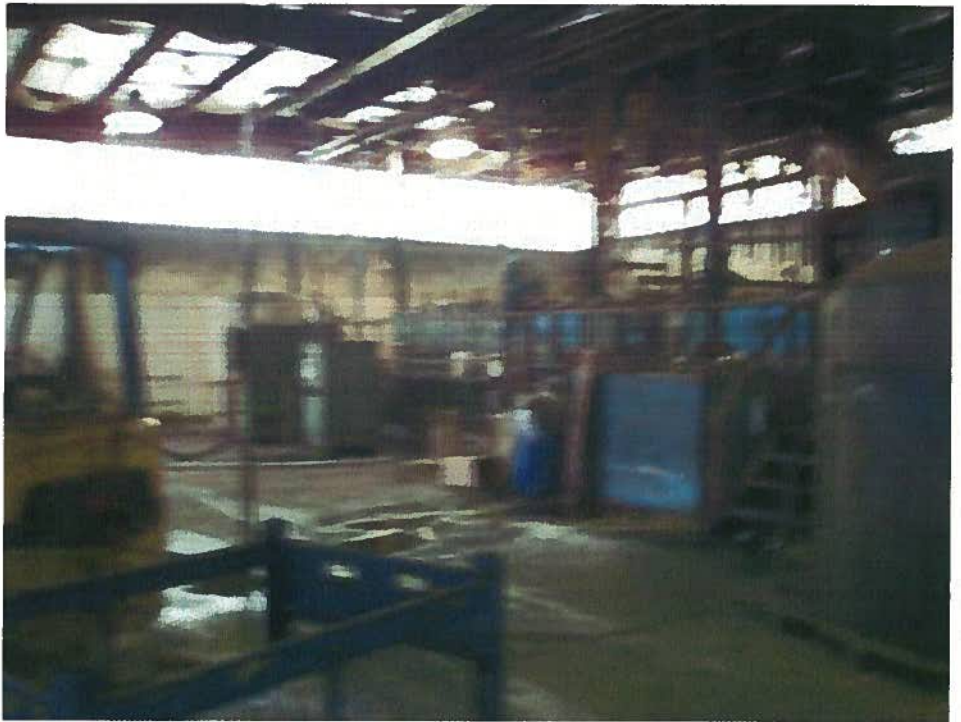
Zinc plating line. Liquid was located on the floor near the plating line.

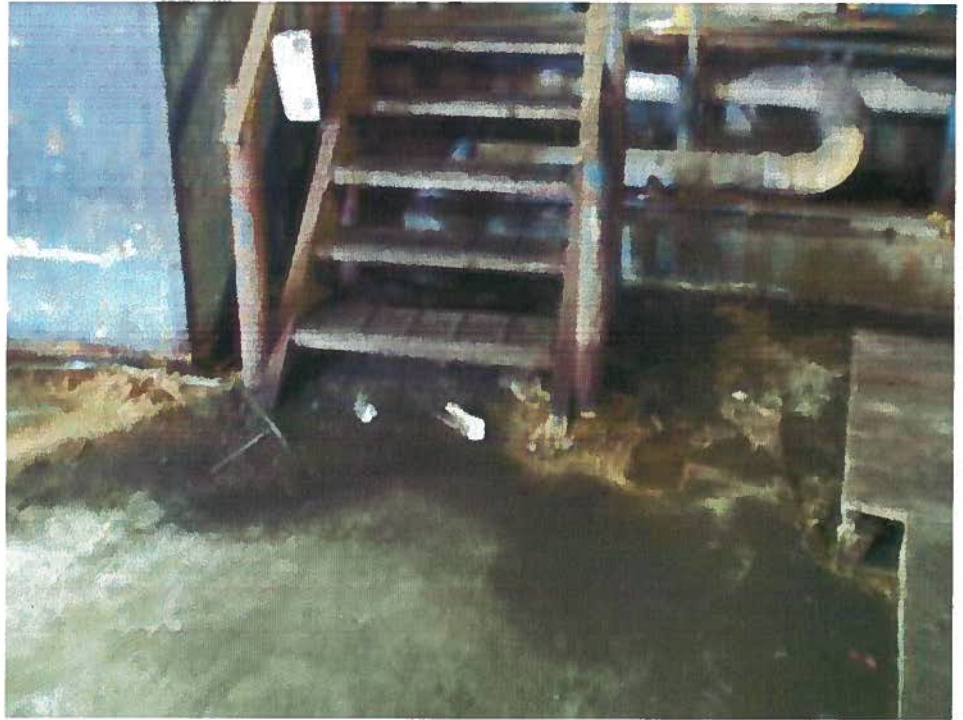
Containment pit was located underneath zinc plating line. Kitty litter was being used to absorb spilled material.

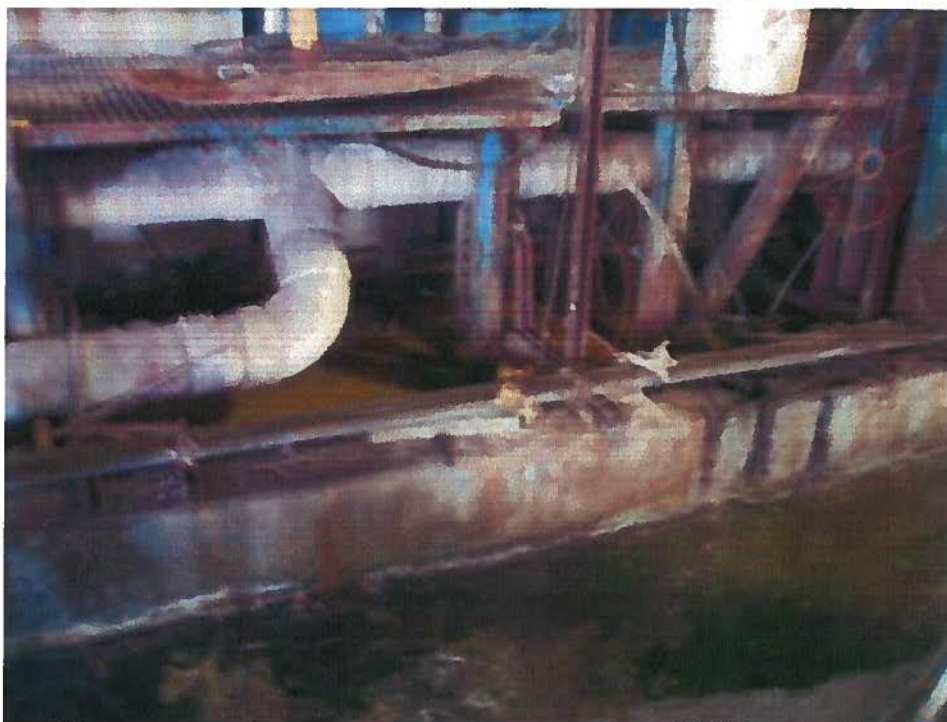
Liquids were being stored on the floor and within the containment pit of the zinc plating line.

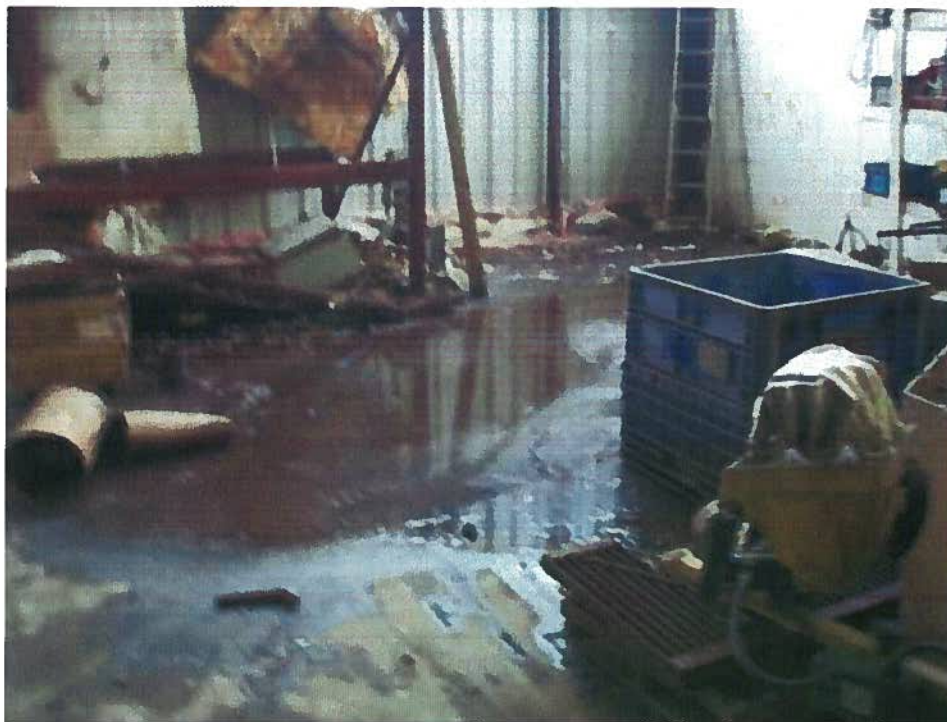
Liquid was located on the floor of the South/West of the facility.

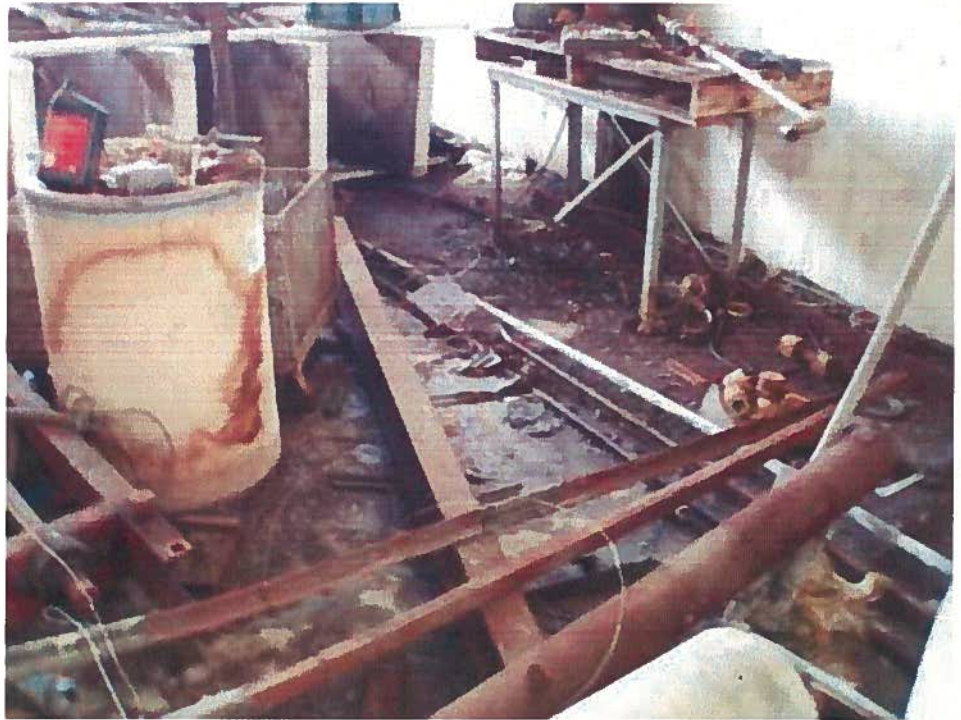
Un-identified material and equipment was located on the floor of the South/West side of the facility.

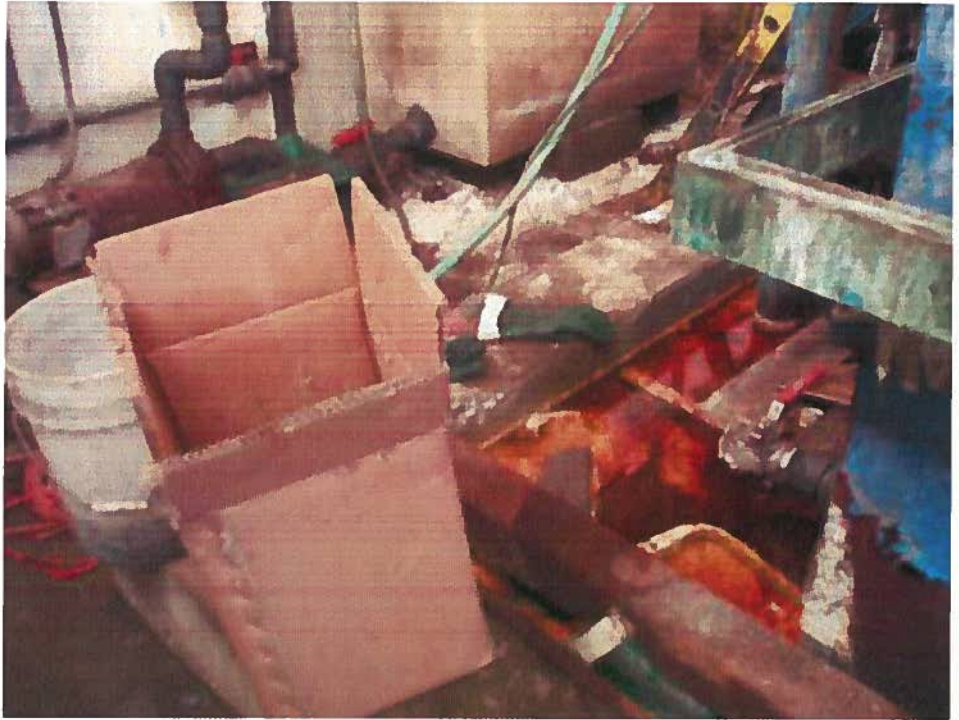
West side of zinc plating line. Red liquid was located in containment pit of line. Material was also being accumulated and stored on the floor near the line.

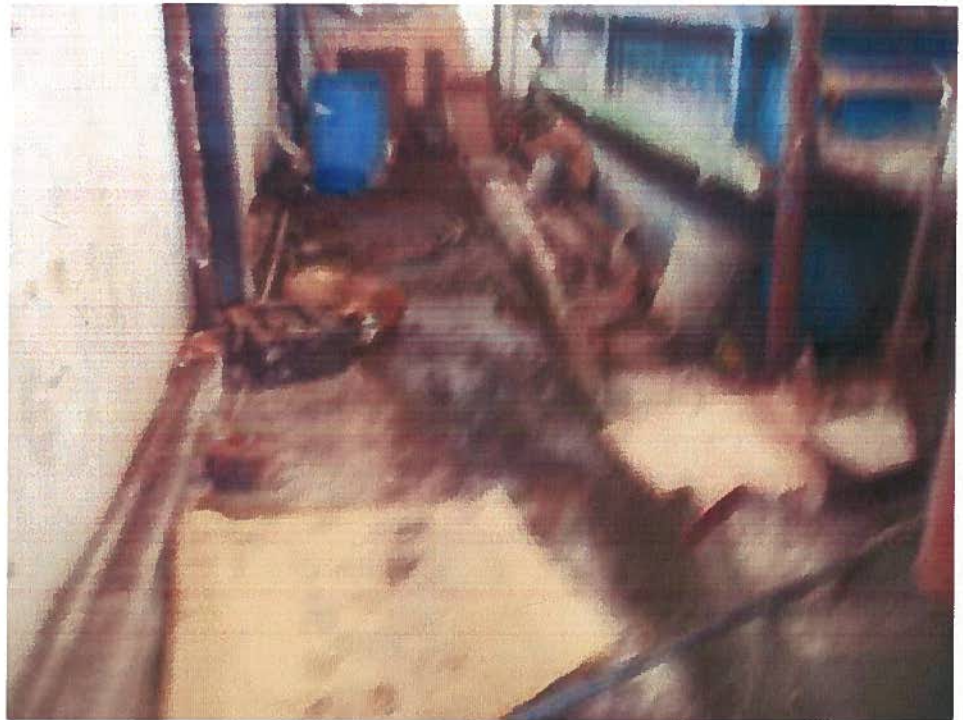
Floor surrounding zinc plating line, located in the South/West room. Debris and material were located on the floor surrounding line.

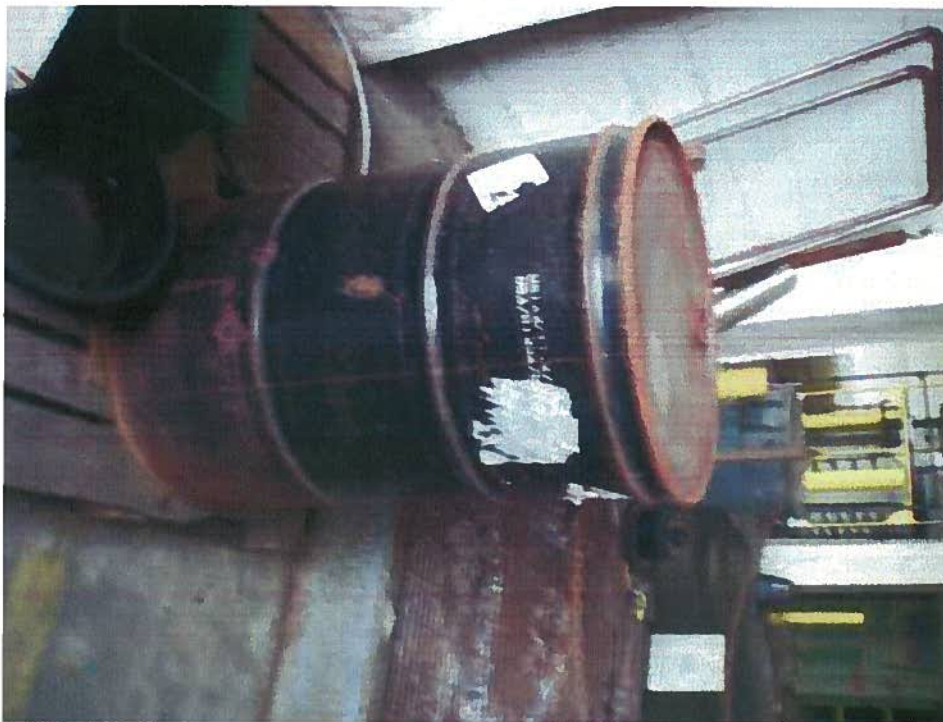
F008 hazardous waste from plating process was being stored in a 55-gallon container as a satellite accumulation area (SAA) container. However, container was not being stored at or near point of operation and was not labeled correctly.

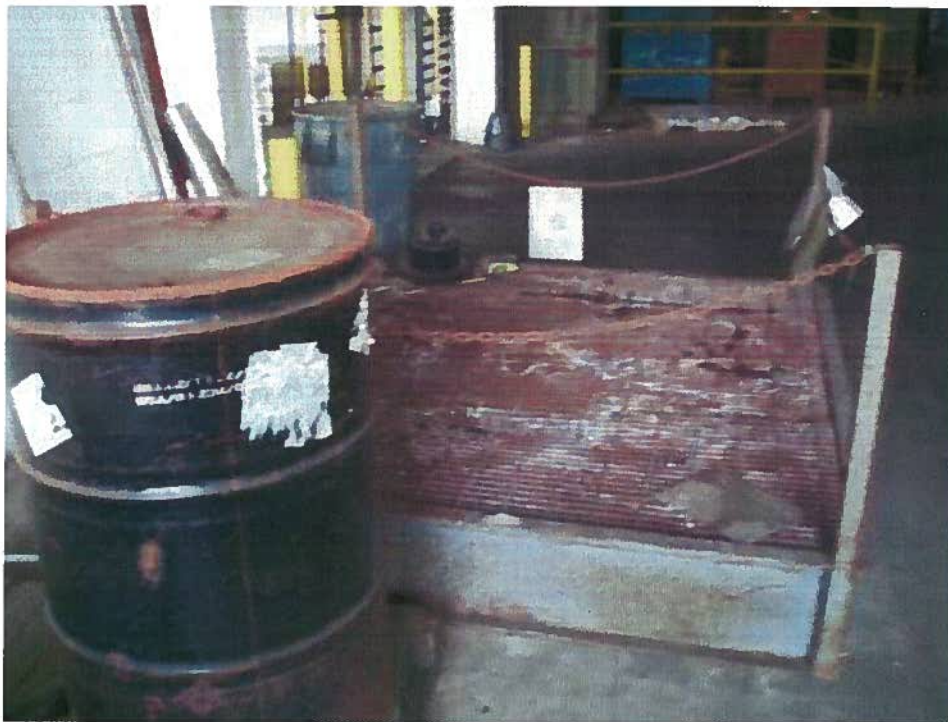
Hazardous waste storage area. SAA 55-gallon container, F008, was not being stored at or near point of operation and was not labeled correctly.

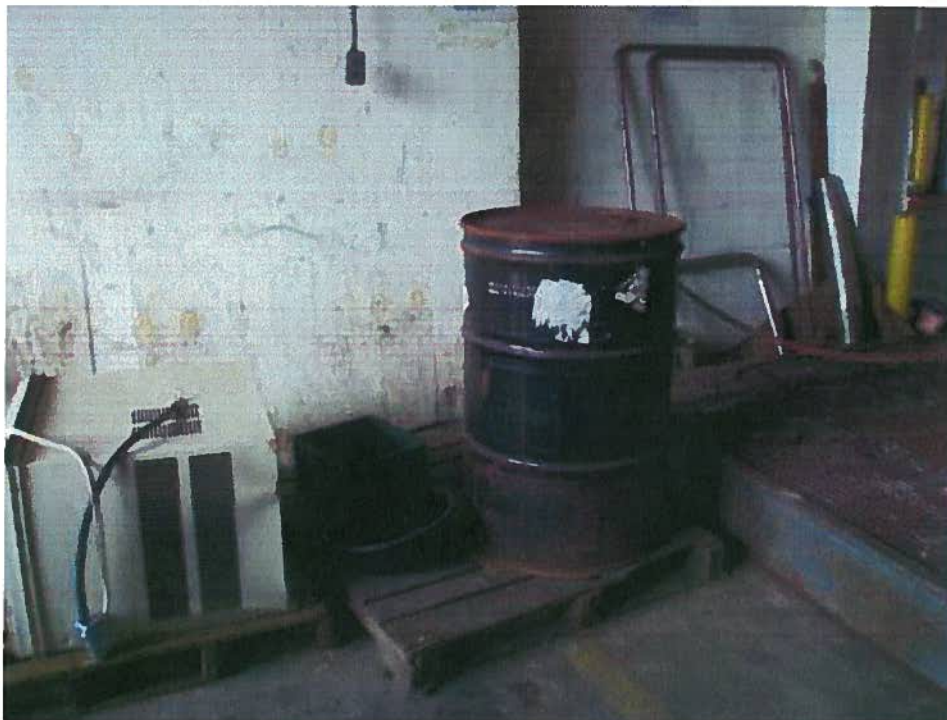
SAA 55-gallon container, F008, was not being stored at or near point of operation and was not labeled correctly.

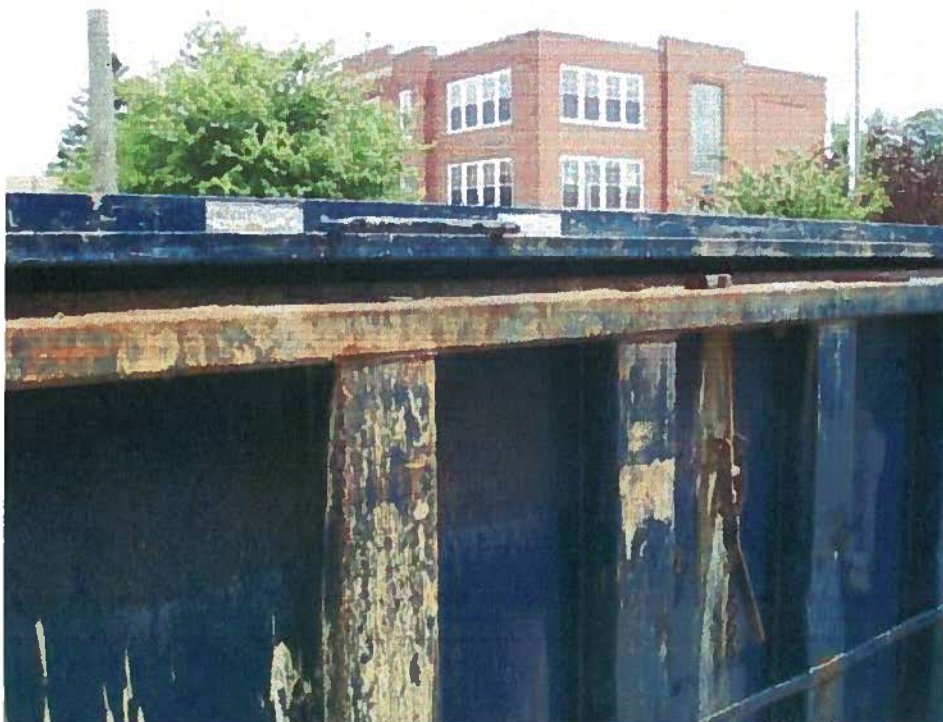
We exited the building on the North/West side of the facility. A roll-off container was located outside. The roll-off was filled to the top, inside of the container, with F006 hazardous waste. The lid was not completely closed and was not capable of physically closing completely due to the design of the container and lid. The container was not labeled with the words, "Hazardous Waste," or with a date of accumulation. Mr. Muzzarelli explained that he was having Enviroline manifest the container off-site, as hazardous waste, for disposal approximately one time per year. The volume of the container was approximately 20 cubic yards. In addition, F006 hazardous waste was located on the container and on the ground. *See, photographs 85 through 90.*

Roll-off container was located outside on the North/West side of facility. Roll-off was filled to top of container with F006 hazardous waste. Lid was not completely closed. No hazardous waste label, or date of accumulation was located on container.

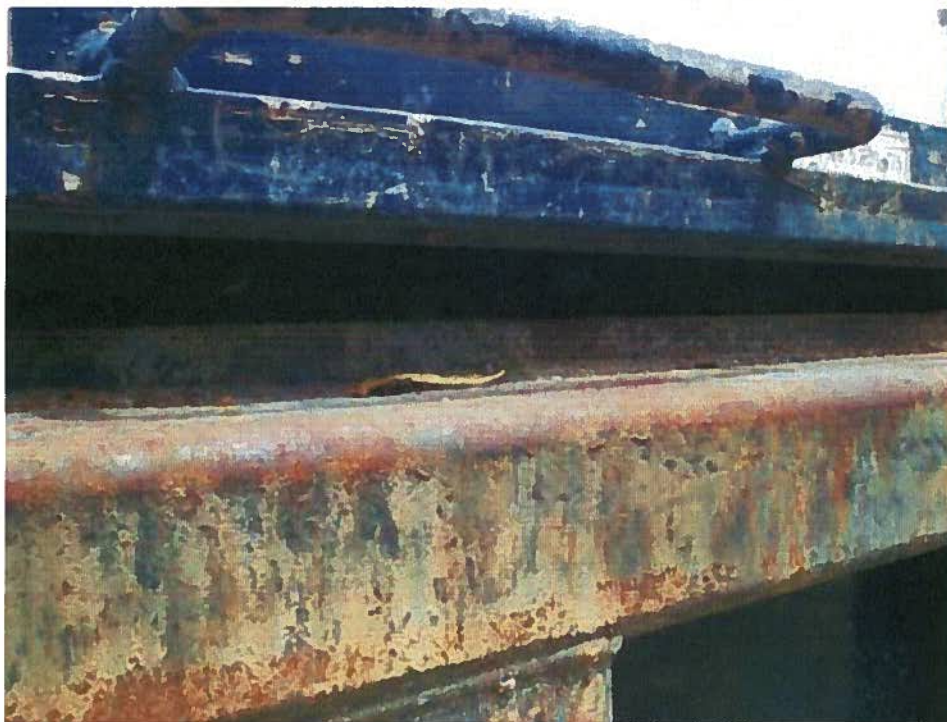
Roll-off container being stored outside on North/West side of facility. Lid was not completely closed on container. F006 hazardous waste was filled to top of container.

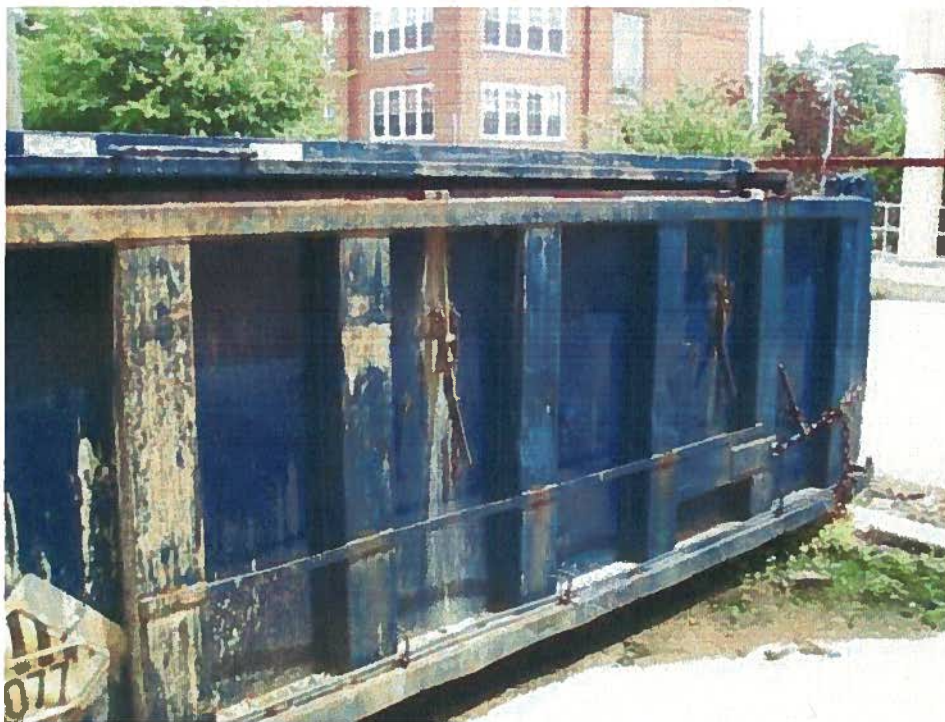
Roll-off container was located outside on the North/West side of facility. Roll-off was filled to top of container with F006 hazardous waste. Lid was not completely closed. No hazardous waste label, or date of accumulation was located on container.

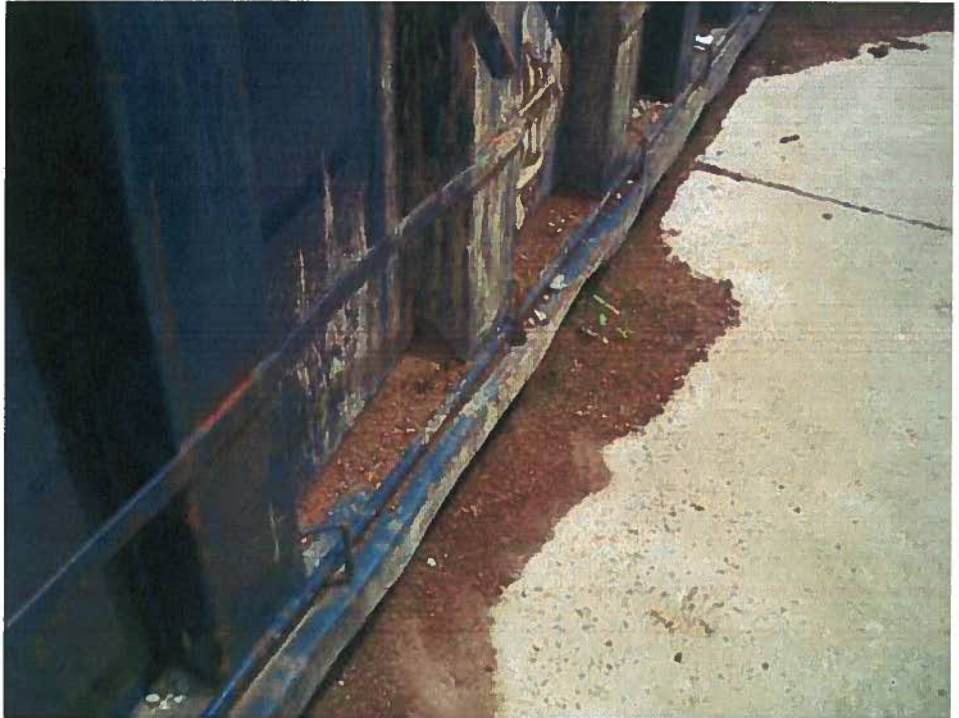
F006 hazardous waste was located on the outside of the roll-off container and on the ground.

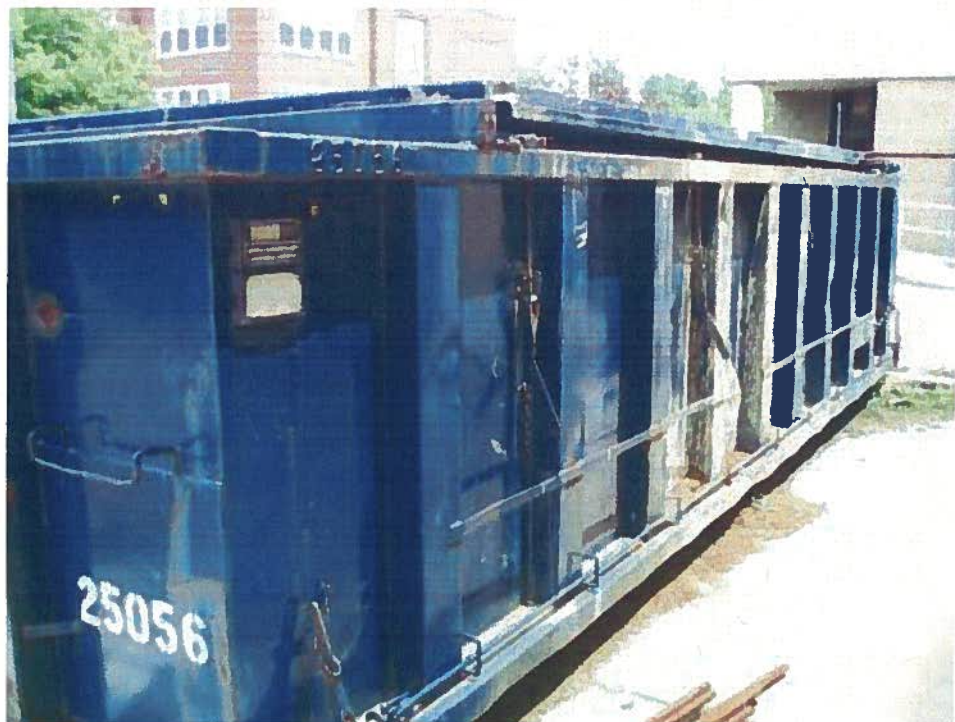
F006 hazardous waste was located on the outside of the roll-off container and on the ground.

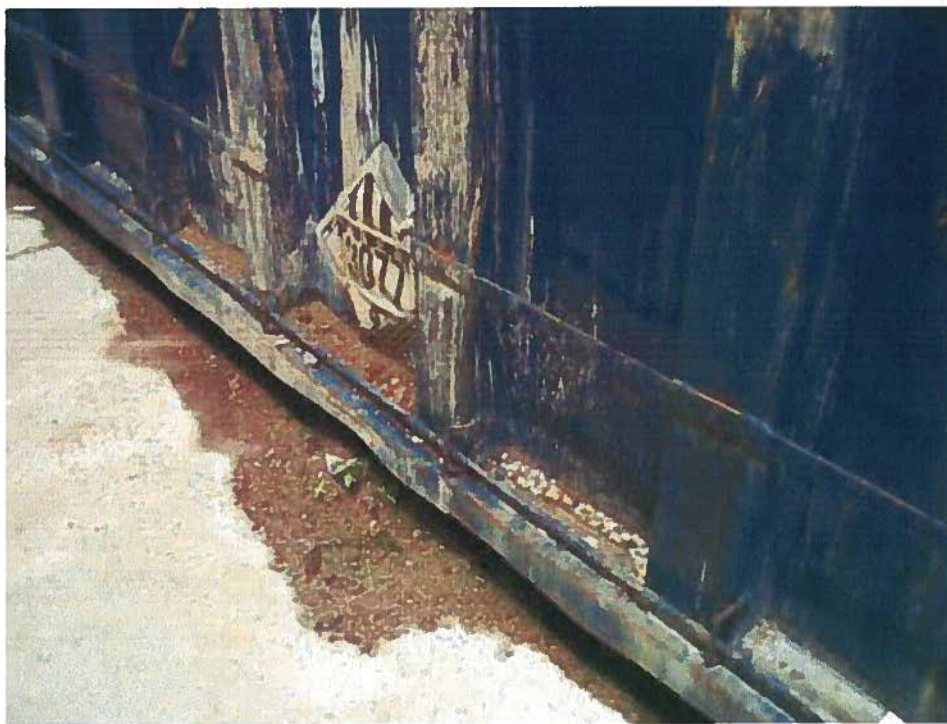
F006 hazardous waste was located on the outside of the roll-off container and on the ground.

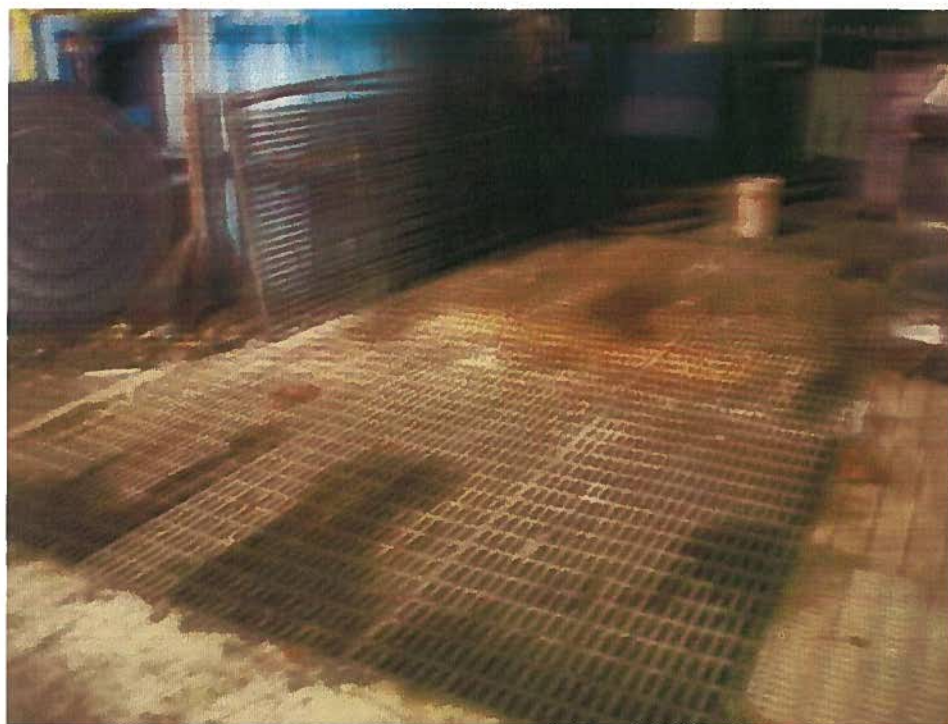
Trench with a grate, located in maintenance room, on West side of facility, was located within the floor. Liquid was being stored within the pit. Cleaner collects inside of grate and is pumped to WWT unit.

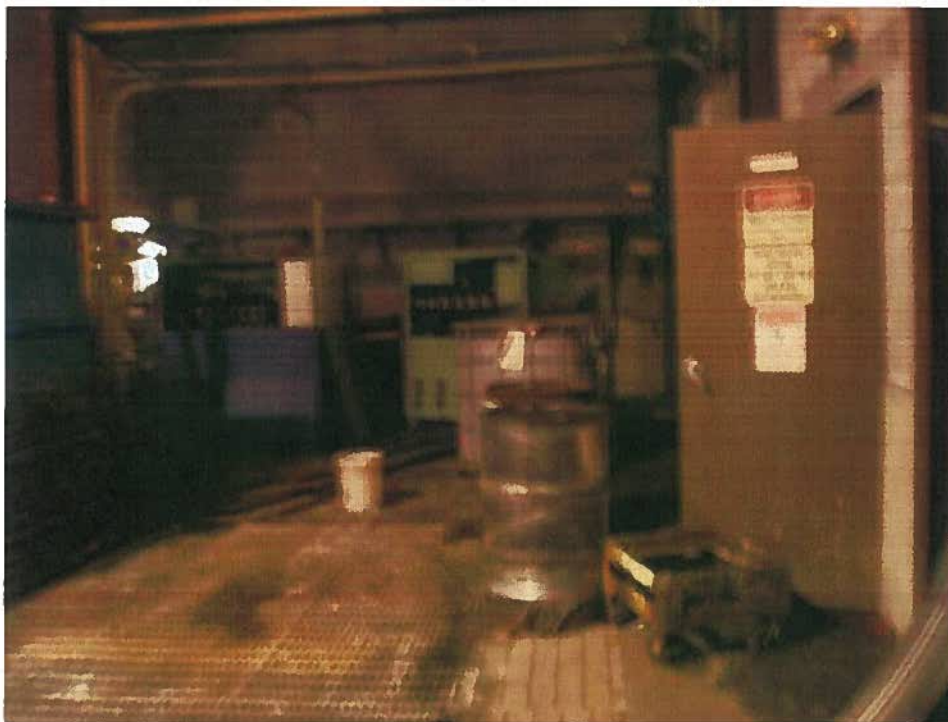
Trench with a grate, located in maintenance room, on West side of facility, was located within the floor. Liquid was being stored within the pit. Cleaner collects inside of grate and is pumped to WWT unit.

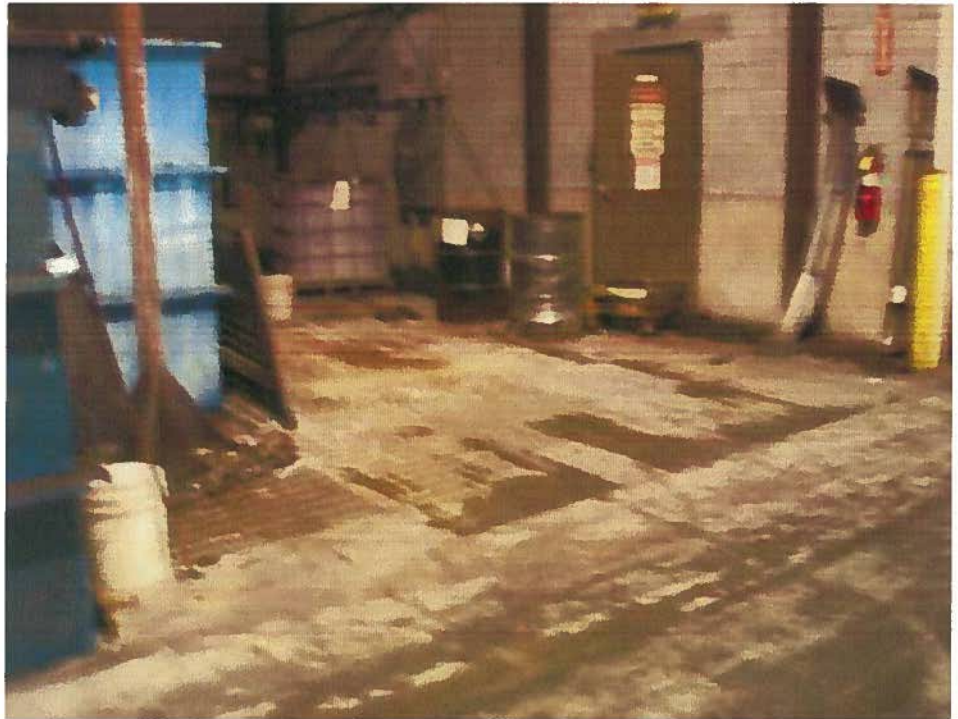
Trench with a grate, located in maintenance room, on West side of facility, was located within the floor. Liquid was being stored within the pit. Cleaner collects inside of grate and is pumped to WWT unit.
